# **Intel® Celeron™ Processor Specification Update**

Release Date: August 1999

Order Number: 243748-017

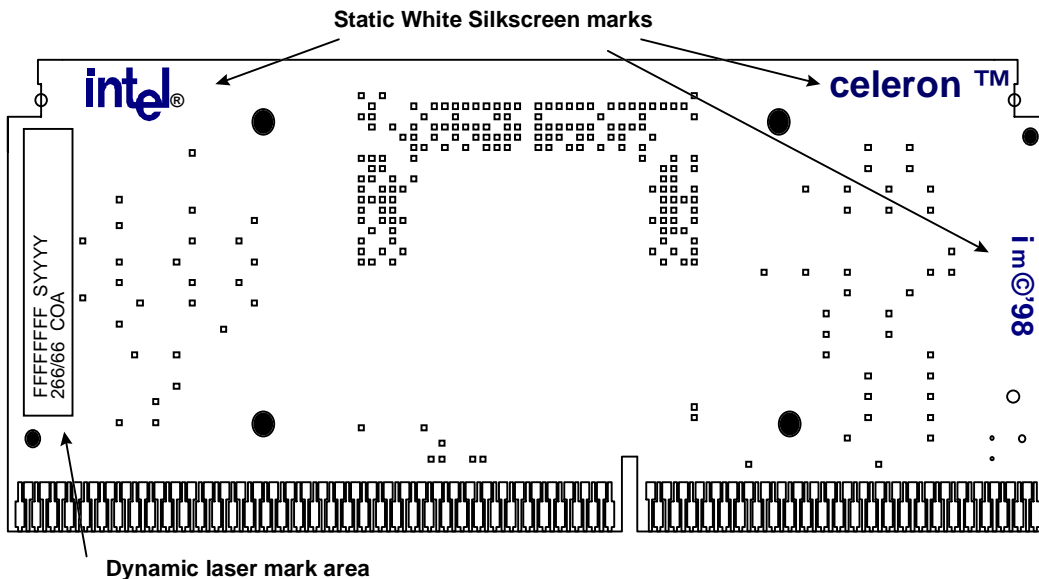
### *Intel® Celeron™ Processor and Boxed Intel® Celeron™ Processor Markings (S.E.P. Package)*

- SYYY = S-spec Number.
- FFFFFFFF = FPO # (Test Lot Traceability #).
- COA = Country of Assembly.

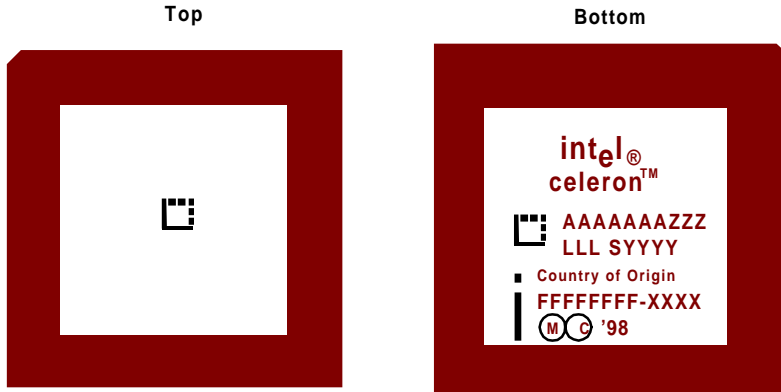
# **Intel® Celeron™ Processor and Boxed Intel® Celeron™ Processor Markings (PPGA Package)**

- AAAAAAA = Product Code
- ZZZ = Processor Speed (MHz)
- LLL = Integrated Level-Two Cache Size (in Kilobytes)
- SYYYY = S-Spec Number
- FFFFFFFF-XXXX = Assembly Lot Tracking Number
